# Flammability of Automotive Child Restraint Seats for Use in Aircraft

November 2001

DOT/FAA/AR-TN01/42

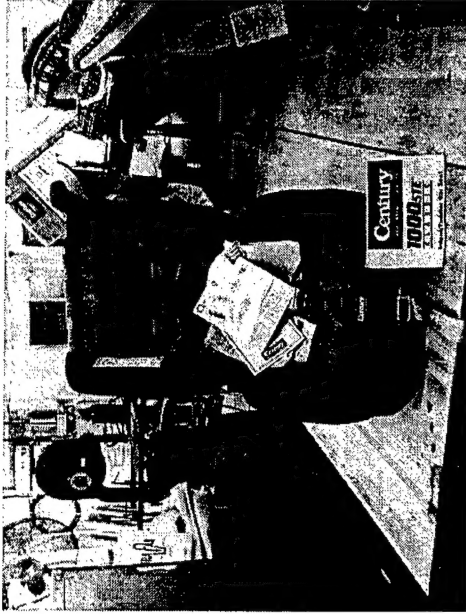
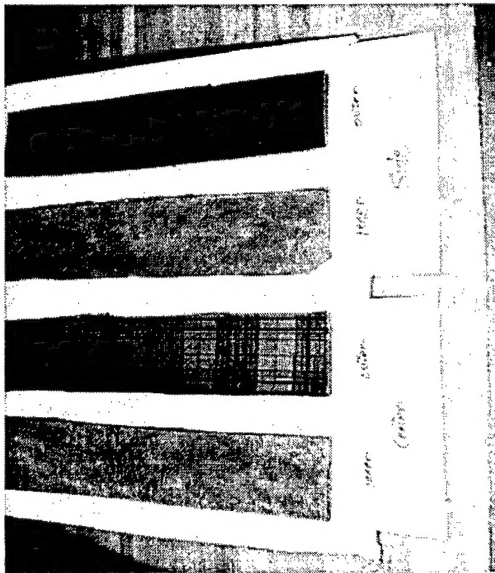
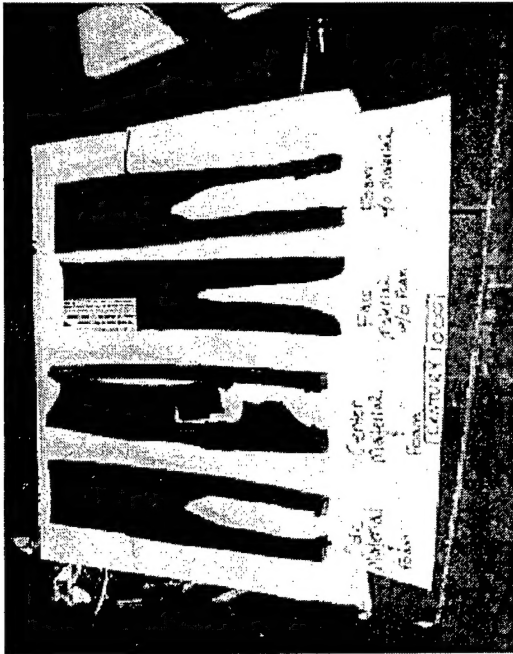
FIGURE 1. CENTURY 1000 STE: \$49.00

- Century 1000 STE. Four of the six seat materials failed the vertical test criteria (figure 1). The center (checked) material was the most flammable, failing both flame time and burn length criteria (entire sample length was burned). Even those materials that passed had relatively long burn lengths (>5 inches).

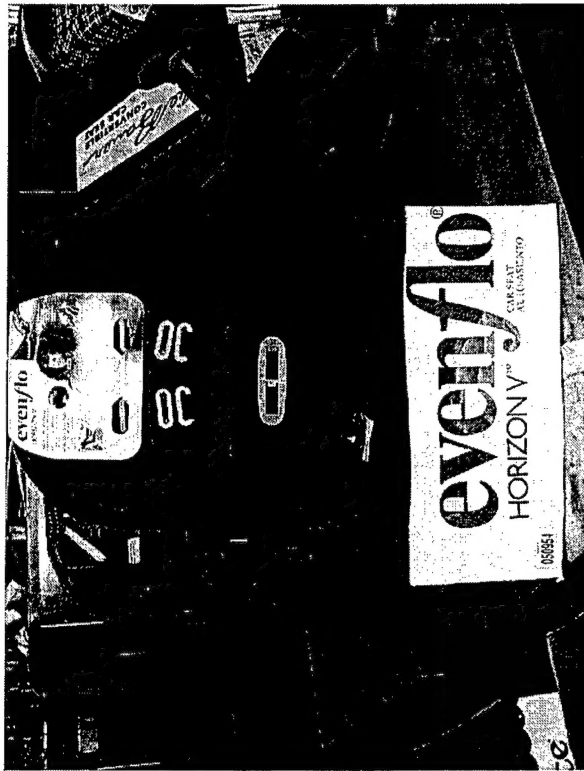
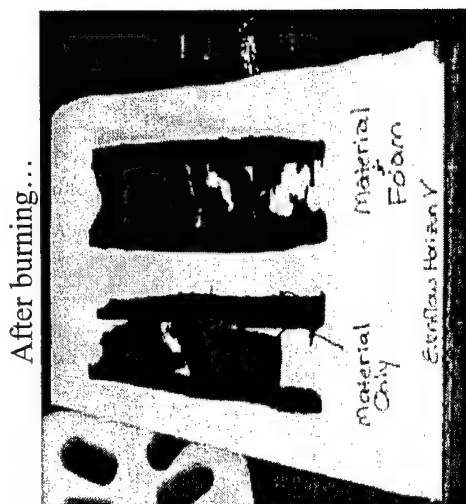
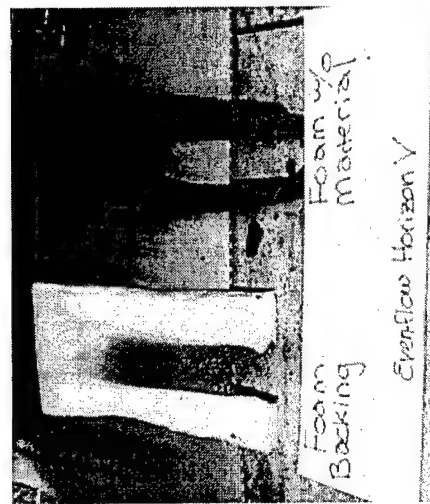
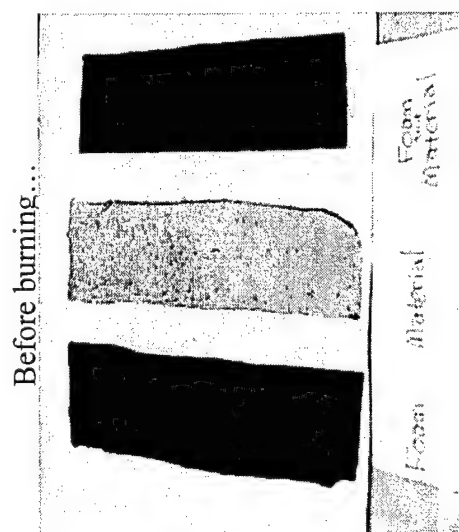
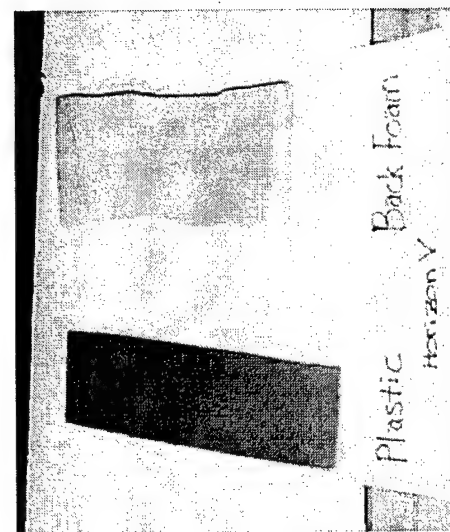
FIGURE 2. EVENFLO HORIZON V: \$79.99

- Evenflo Horizon V. Four of the five seat materials failed the vertical test criteria (figure 2). Three of the failed materials exceeded both the allowable flame time and burn length (entire sample length was burned).

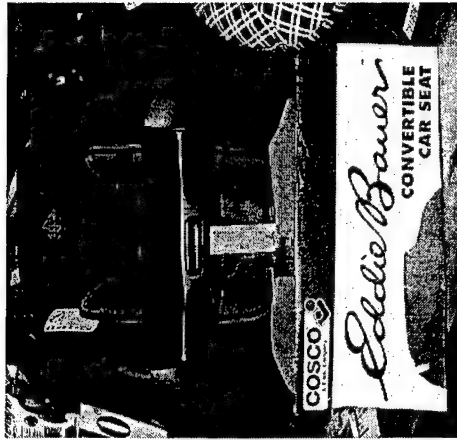
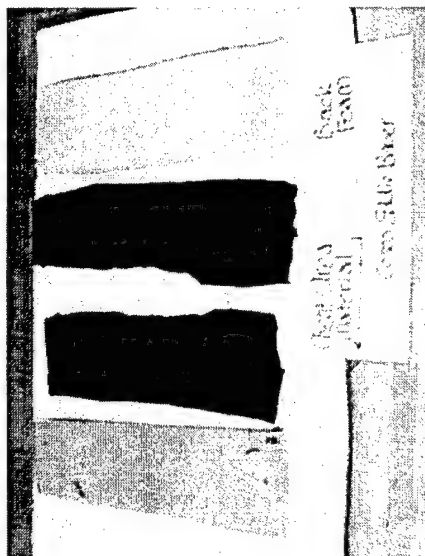
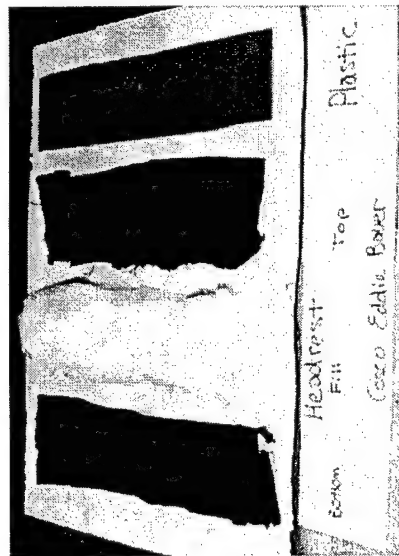
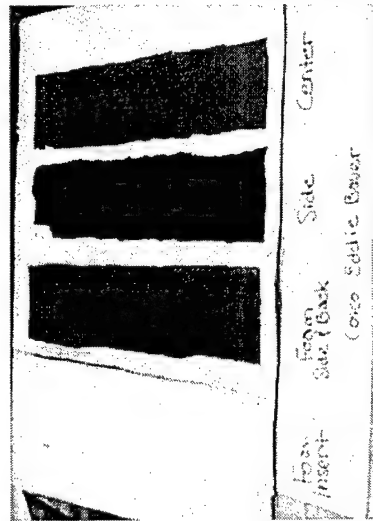
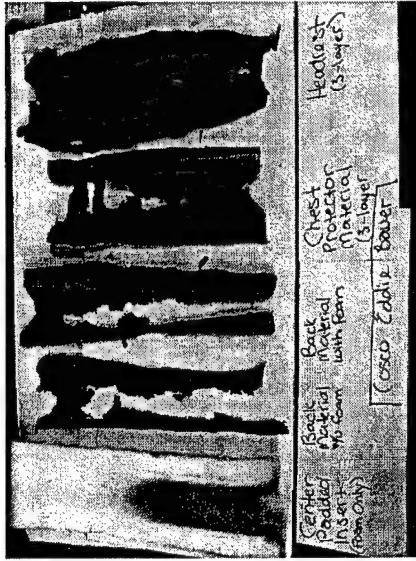
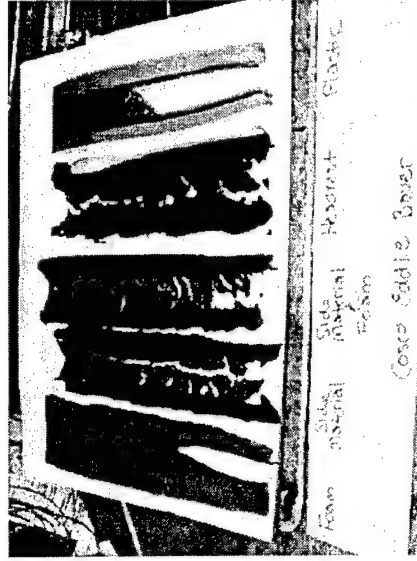
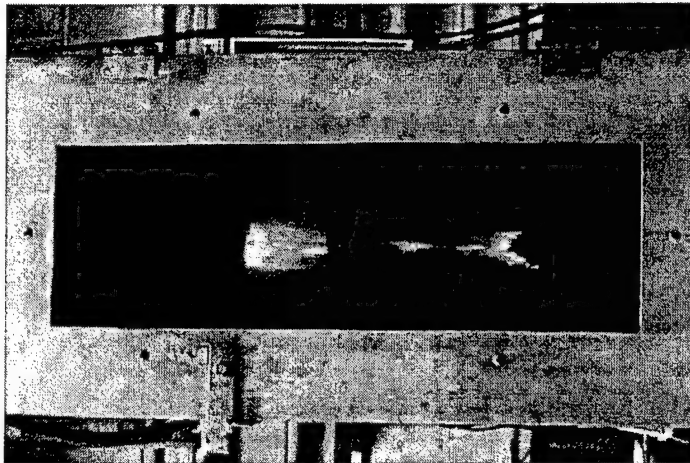
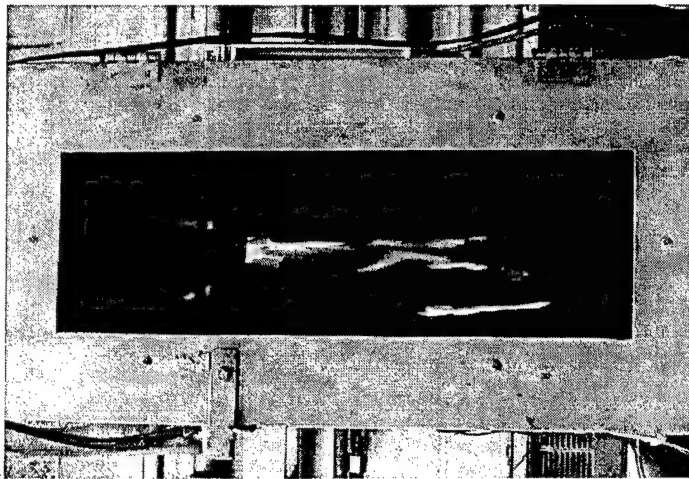
FIGURE 3. COSCO EDDIE BAUER: \$99.99

- Cosco Eddie Bauer. Seven of the eight materials failed the vertical test criteria (figure 3). All of the samples that failed exhibited very high flames. The center-padded insert foam, which passed, was the only material that did not exhibit high flames. One specimen of fabric material was tested in accordance with the FMVSS test procedure (horizontal orientation). A burn rate of 3.8 inches/minute was measured, just slightly less than the allowable 4.0-inches/minute value.

NOTE: The Eddie Bauer seat materials had substantially higher flames than the other seven seats in the test. To show the magnitude of these flames, here are pictures of the Eddie Bauer seat during actual testing.

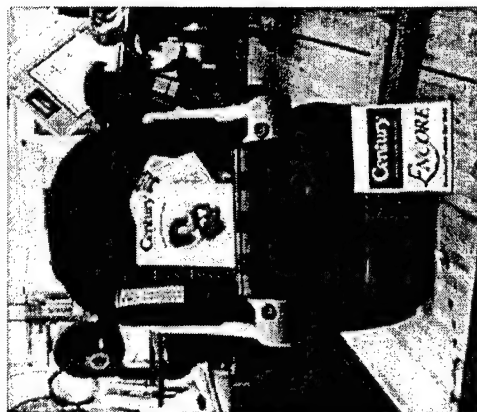
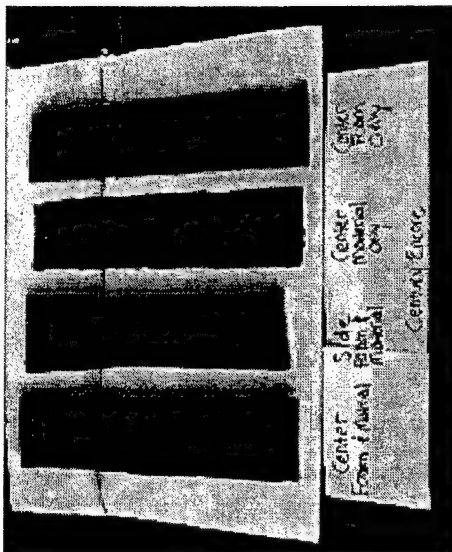
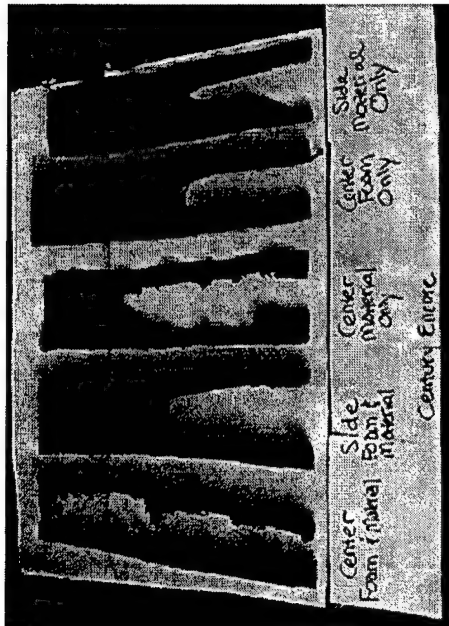
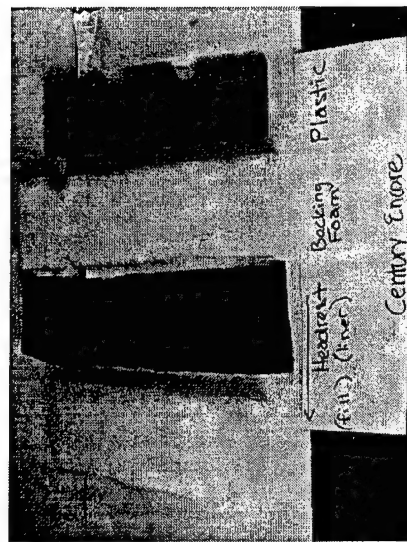
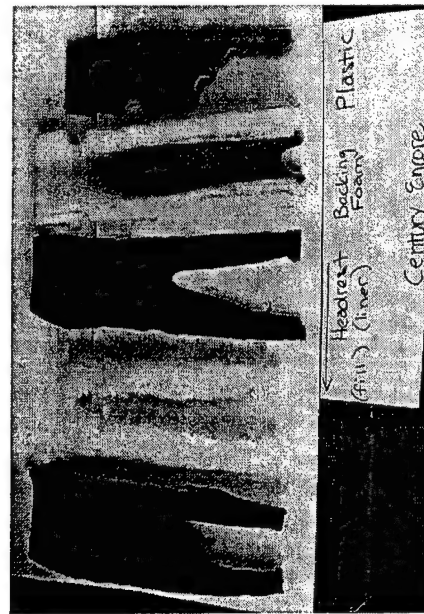
FIGURE 4. CENTURY ENCORE: \$89.00

- Century Encore. Four of the nine seat materials failed the vertical test criteria (figure 4). Some of the materials generated heavy smoke, including two of the samples that passed the test criteria. Again, even those samples that passed had relatively long burn lengths (>5 inches).

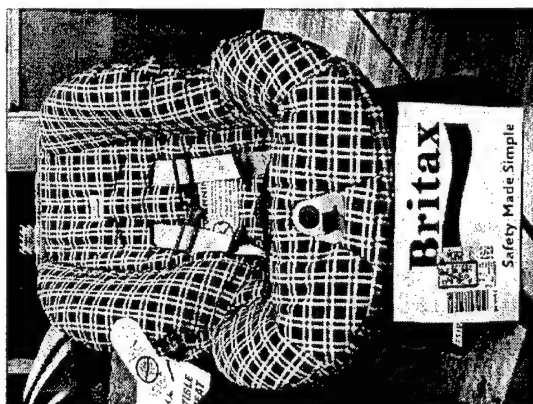
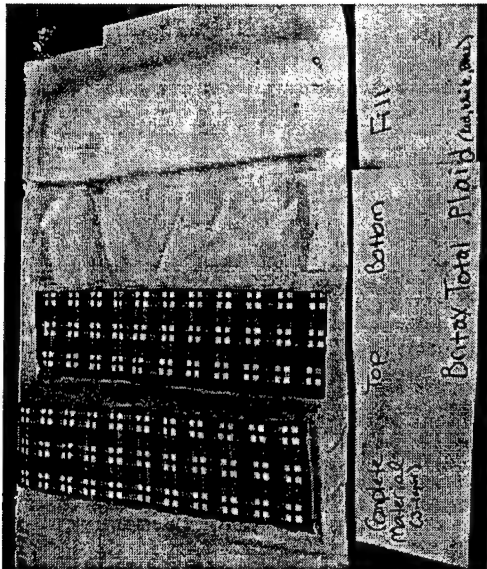
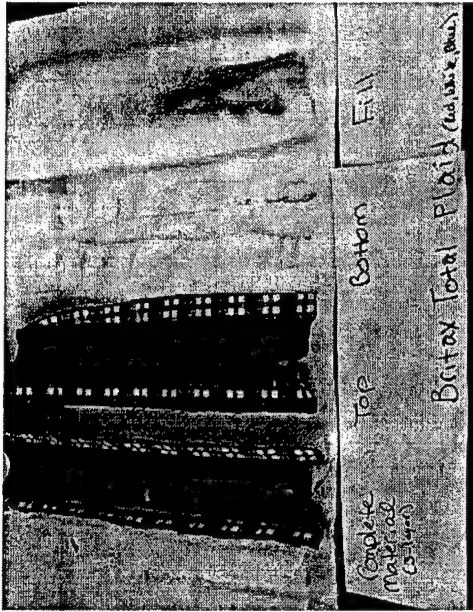
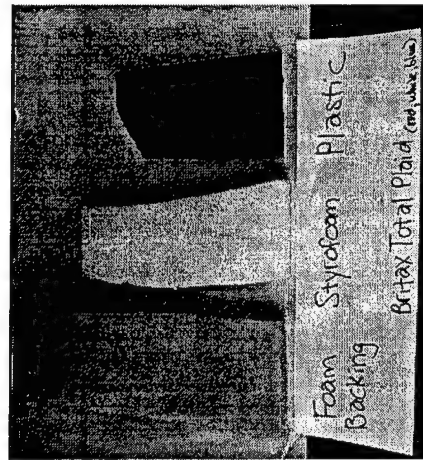
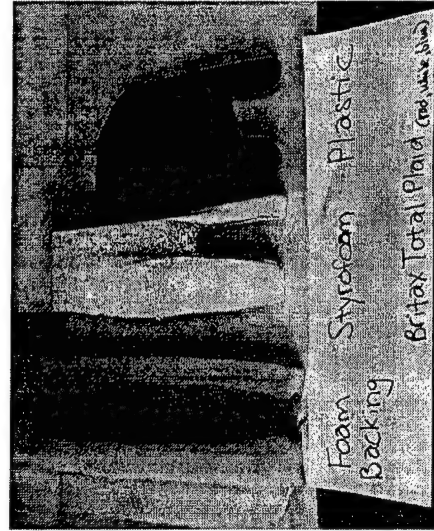
FIGURE 5. BRITAX TOTAL PLAID: \$199.99

- Britax (Total Plaid). Four of the seven seat materials failed the vertical test criteria (figure 5). Some of the materials, including a sample that passed, exhibited heavy smoke and, in one case, fast burning. The two materials that passed had relatively long burn lengths (>5 inches).

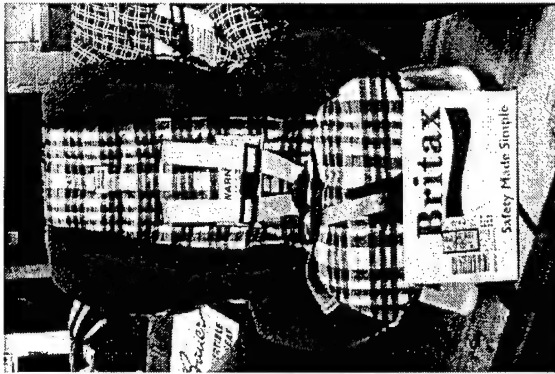
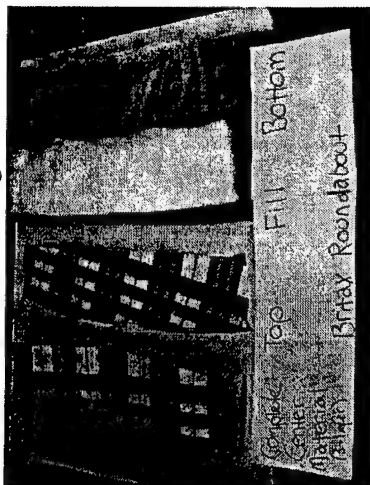
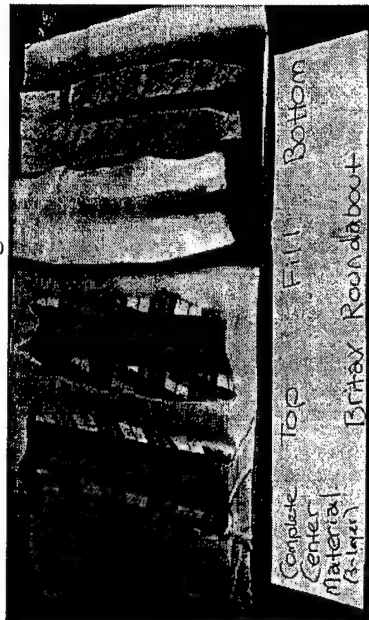
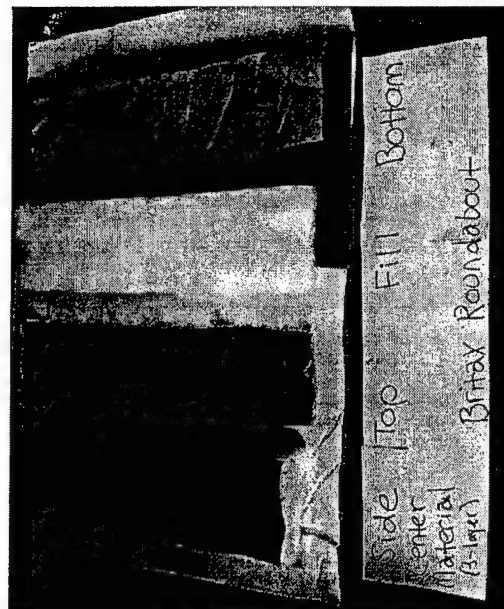
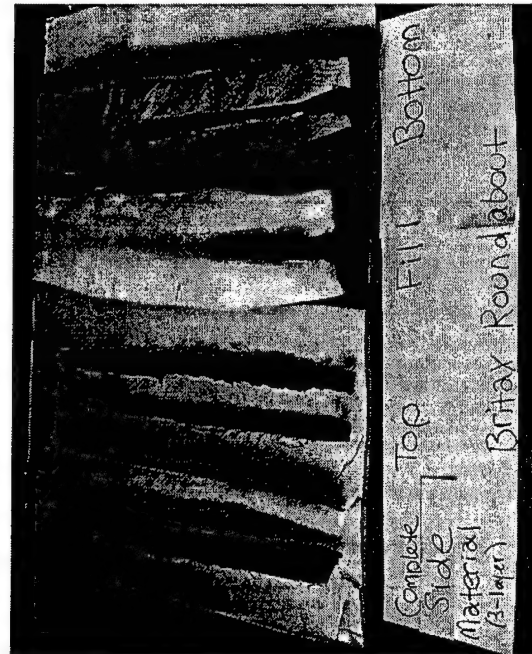
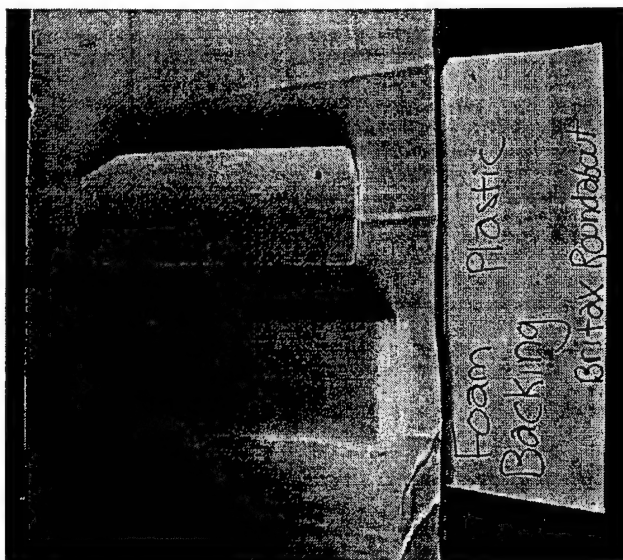
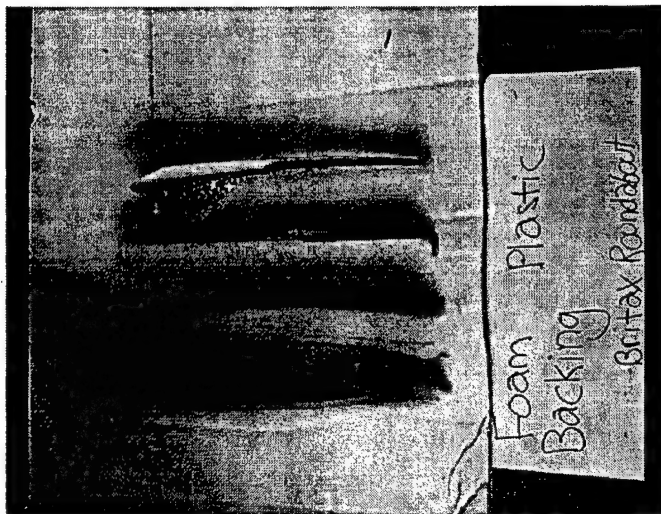
FIGURE 6. BRITAX ROUNDABOUT: \$199.00

- Britax Roundabout. Six of the eight seat materials failed the vertical test criteria (figure 6). Those materials that passed had relatively long burn lengths (7 and 8 inches). Four of the materials burned along the entire sample length.

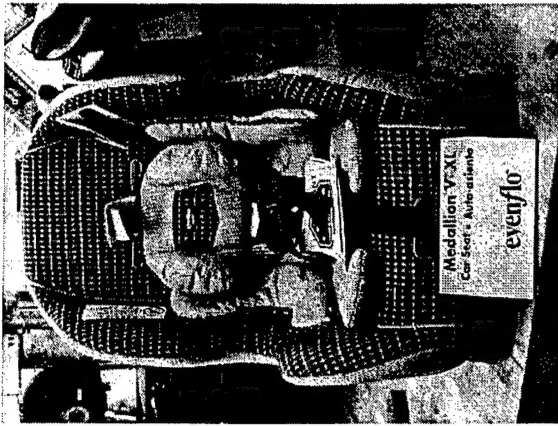
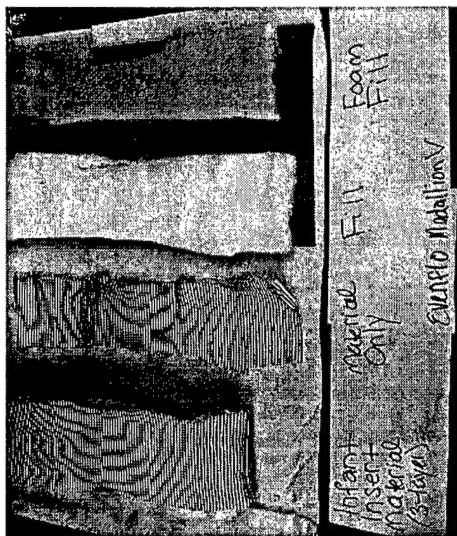
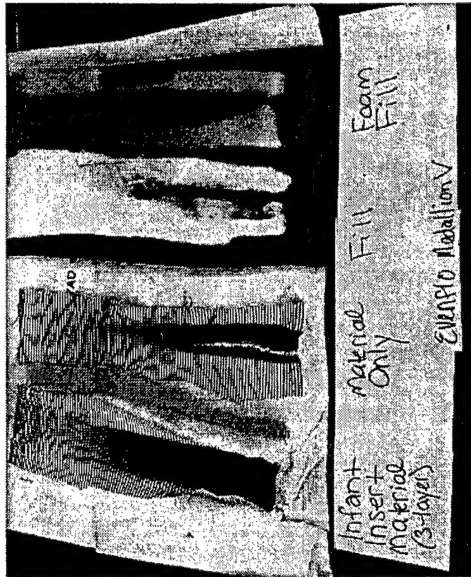
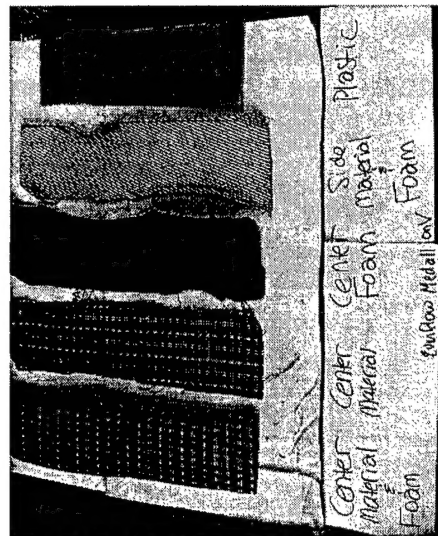
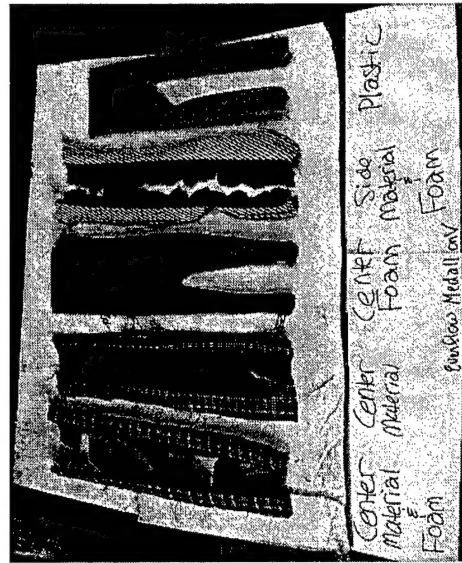
FIGURE 7. EVENFLO MEDALLION V: \$139.99

- Evenflow Medallion. Six of the nine seat materials failed the vertical test criteria (figure 7). The center material and foam produced the heaviest smoke of all seat materials in the

test series. It appeared that the dense smoke inside the test chamber was the cause of flame extinguishment. When it appeared that the flame was out and the door of the test cabinet was slightly opened to evacuate the smoke, the flame reignited apparently due to oxygen entering the cabinet.

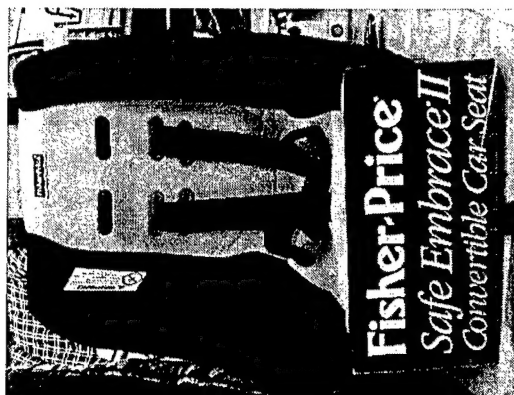
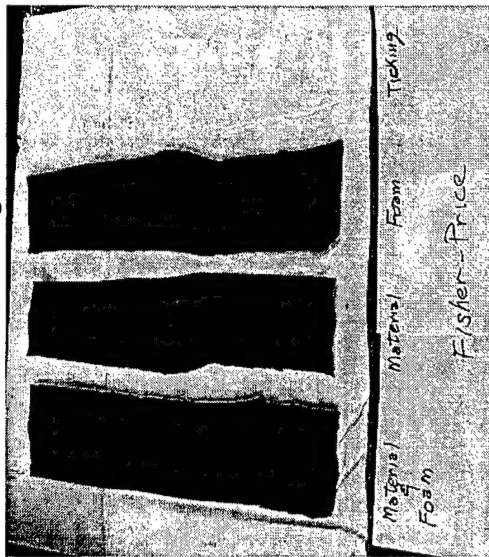
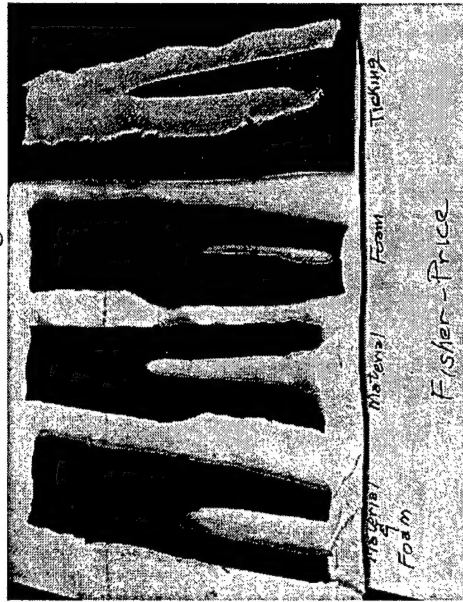
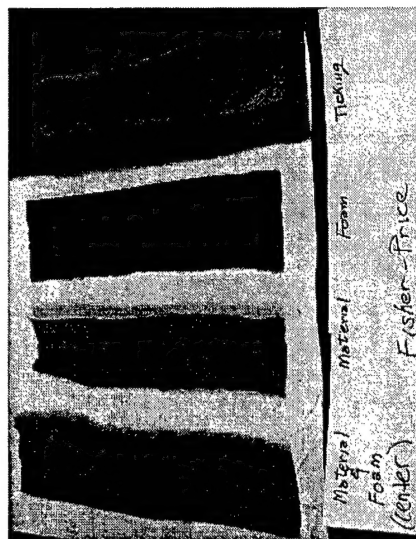
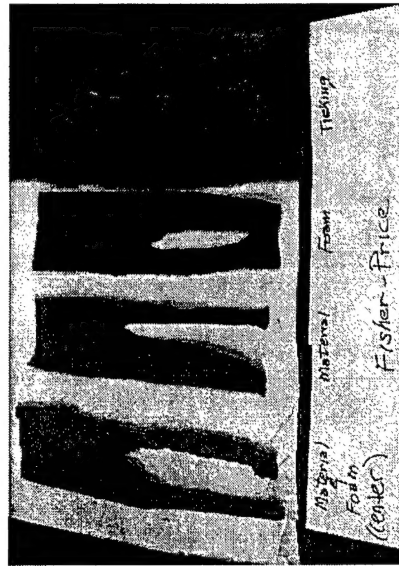
FIGURE 8. FISHER PRICE SAFE EMBRACE II: \$149.99

- Fisher Price Safe Embrace II. Three of the nine seat materials failed the vertical test criteria (figure 8). The materials that passed had relatively long burn lengths ( $\geq 5$  inches).
